# **The Road Inventory of Hanalei National Wildlife Refuge Kilauea, HI**

Prepared By:  
Federal Highway Administration  
Central Federal Lands Highway Division  
April 2013

# Hanalei National Wildlife Refuge - 12522

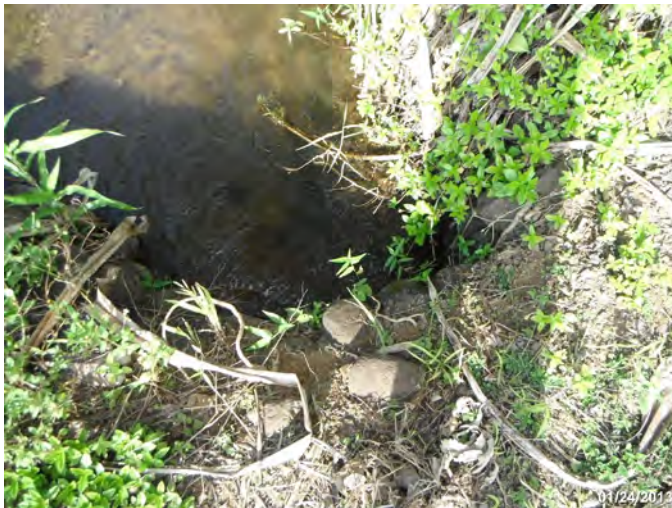
Photo: HANA\_C4\_1331 Route: 801  
Metal Culvert 40ft long 24in dia. 3ft deep

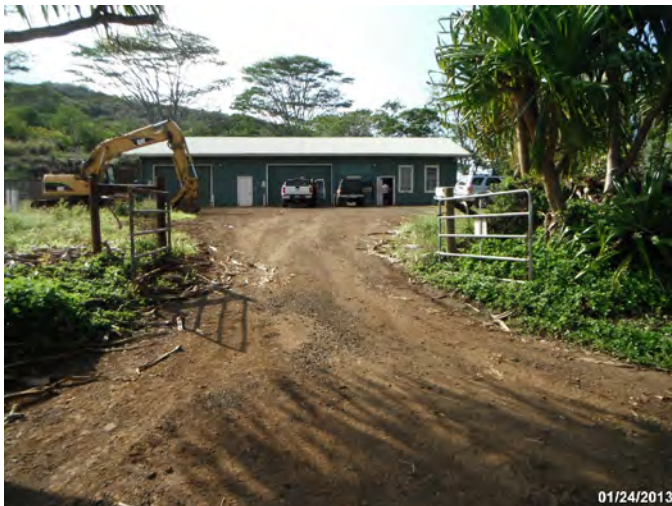
Photo: HANA\_C4\_1330 Route: 801  
Metal Open Rail Gate

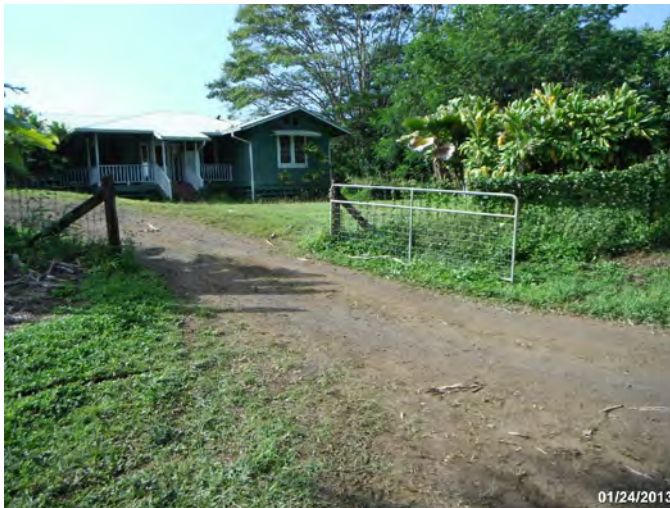
Photo: HANA\_C4\_1333 Route: 802  
Metal Open Rail Gate
